**Thompson Falls Hydroelectric Project**  
**FERC Project No. 1869**  
**Final License Application**  
**Volume II of IV (Public)**  
**Exhibit E: Environmental Report**

Prepared by:  
**NorthWestern Energy**  
Butte, MT 59701

With Support From:  
**GEI Consultants, Inc.**  
Portland, OR 97239

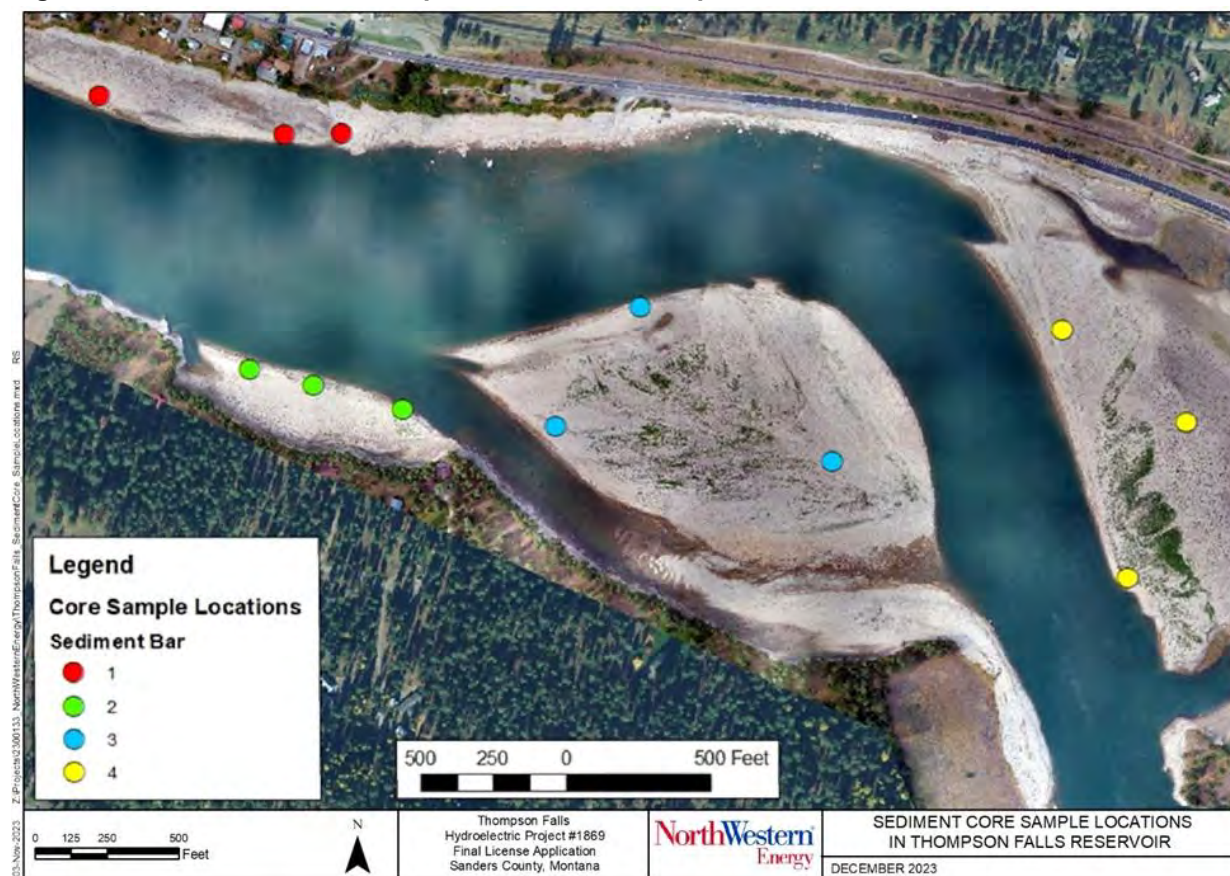
**Figure 6-10: Sediment core sample locations in Thompson Falls Reservoir on 7/13/20.**

Analytical results from the sediment core samples are shown in **Table 6-3** through **Table 6-5**, below. Table 6-3 shows the results of the Toxicity Characteristic Leaching Procedure (TCLP) metals analysis for each composite sample. TCLP is an analysis used to determine the potential
